**MILITARY SEALIFT COMMAND**

Understanding Lead Paint

MARINE SAFETY ALERT

INSPECTION OF FUEL OIL QUICK-CLOSING VALVES

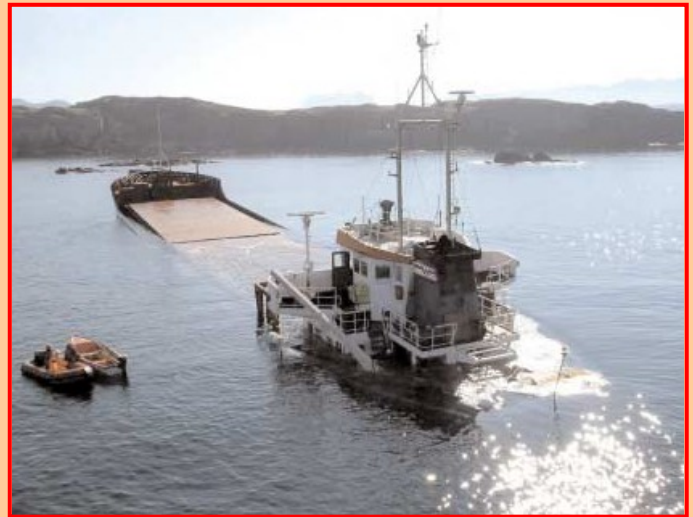
In 2003, the MV JAMBO was grounded when the chief mate fell asleep on watch and missed a critical course change. Unable to control flooding from the grounding the Jambo lost her stability and sank four hours later. The MAIB inspectors concluded that, *“the mate had fallen asleep as a result of very high levels of fatigue, caused by the cumulative effect of an irregular working pattern in which the six-on, six-off watches were compounded by regular port visits.”* MAIB Accident Investigation Report

From: MAIB. MV JAMBO grounded at the entrance of Loch Broom, Scotland.

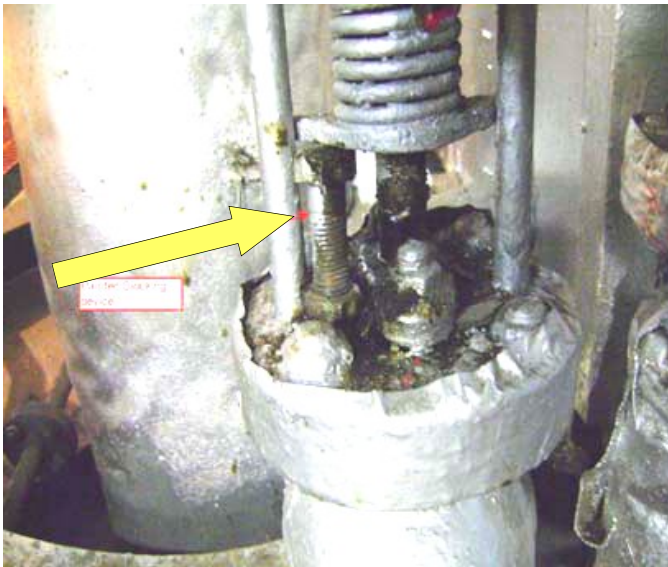
QCV blocked utilizing a bolt to hold in the open position.

(Note: the painted portion on the bolt indicating possible long term condition.)

The U.S. Coast Guard **strongly recommends** that owners /operators, vessel engineers, PSCOs, Class society and other machinery space inspection personnel ensure:

- a) The QCV operating system is capable of remotely closing all valves as designed; some systems close valves sequentially and others simultaneously.
- b) There is a maintenance plan in place including technical manuals containing diagrams and information that describe the system components, required spare parts, operation, maintenance and repair.
- c) That all engine department personnel can identify the location of each valve, the respective remote closure and how to close them locally and remotely in an emergency.

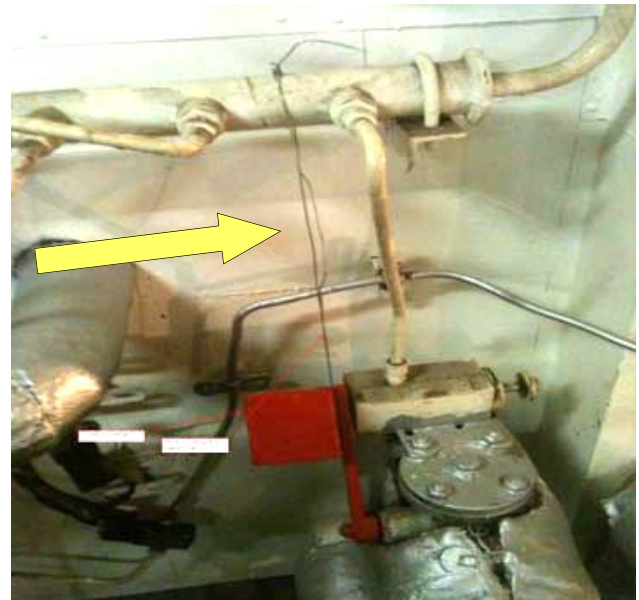
QCV blocked utilizing wire to hold closing weight up and the valve in the open position.

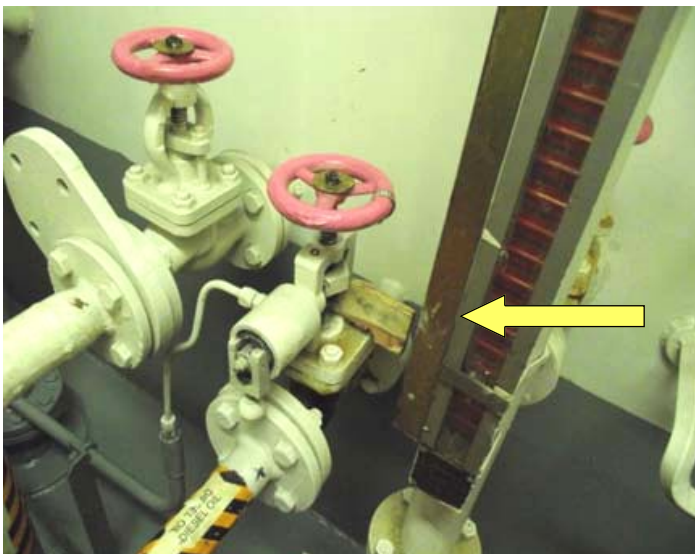
QCV blocked utilizing a wooden block to hold the valve in the open position.
